Rapid geomorphic assessment of the Musimusi River in Balingasag Misamis oriental Philippines

Key words: Channel stability index, Rapid geomorphic assessment, Stream reach

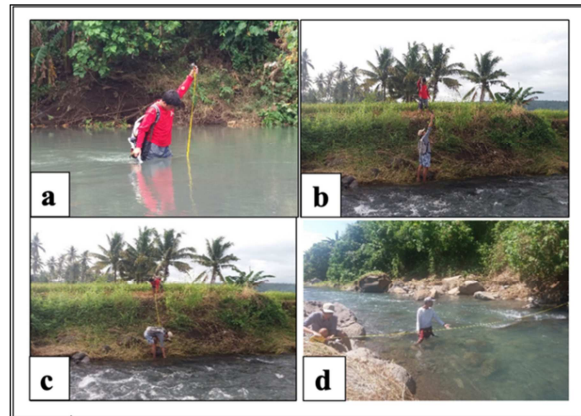
Fig. 2. Field Measurements on the study area; a) river stage at base flow b) bank height c) bank face length and d) channel width

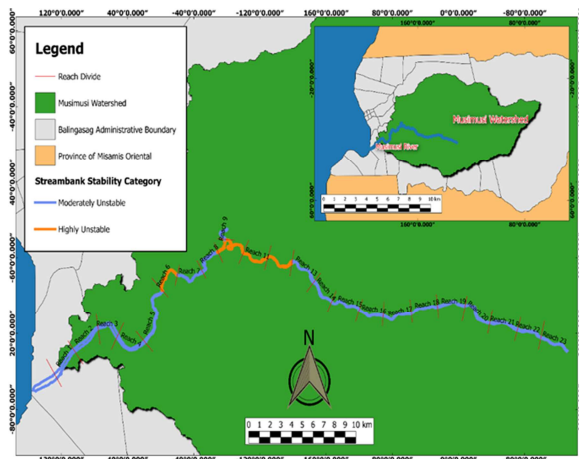
One key study component was to rank potential reaches for streambank stabilization in the Musimusi River. Consequently, the RGA scores were utilized to categorize the banks' stability in each specified section, using RGA scores as depicted in Fig. 4. A total of five sites with twenty-three (23) stream reaches were studied in the study area. These sites (Fig. 1) are marked with letter identifiers, and stream reaches (Fig. 4) are marked with numbered identifiers.

Fourteen (14) of these reaches are in the Camuayan River, one (1) is in the Biasong Stream, and eight (8) in the Musimusi River. Four (4) stream reaches got a CSI score higher than 20, considered "highly unstable." These are the streams that reach 6, 10, 11, and 12, with the former 3 having a CSI score of 22 and

the latter having a CSI score of 21, as shown in Table 1. The CSI scores for at least one reach at all the sites were on the higher side of the "moderately stable" category, indicated by the remaining with CSI scores between 10-20, which is deemed "moderately unstable".

Fig. 4. The stability category of the stream reaches the Musimusi River

Channel instability of reaches 6, 10, 11, and 12 was evident during the RGA assessment due to their higher width/depth ratios, steeper slopes due to decreased sinuosity, and excessive bar deposition, which in turn increases stress in the near-bank region. An increase in channel slope, discharge, or decrease in sediment supply has tipped the scale toward degradation. The channel cross-section is deepening due to excess scouring. The channel has disconnected from the floodplain. Bank erosion and cutting are excessive along the inside and outside bends, and bank angles are starting to steepen. When this happens, a stream can be less competent to move its sediment and, thus, aggraded. The unstable sites are located throughout the mainstem, which indicates active channel processes occurring throughout the Upper and Middle Musimusi River and not just in isolated areas. These active channel processes include deepening the channel bed and widening the channel; this was evident in the unstable sites (Eaton *et al.*, 2020).
