## Habitat assessment of Muleta River in Bukidnon, Philippines

Rasel A. Lacandula\*, Victoria T. Quimpang

Article published on August 10, 2022

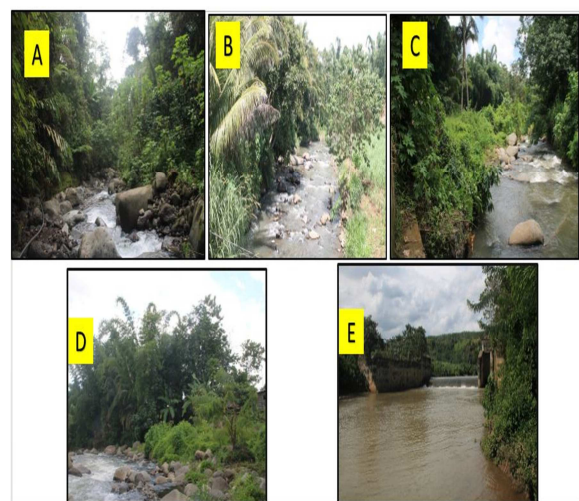
There is a difference between the water color coming from Muleta which is clear and Bongbong River is a bit brownish in color. It is very evident at the river junction. Lastly, Muleta dam located in Brgy. Adtuyon, is generally flat with surrounding households, agricultural, shrub and some parts covered with forestland vegetation (Fig. 4E).

It is a flood prone area. Hanging bridge is present in the site utilized by residents and vehicles as a pathway.

**Fig. 4.** Assessment Areas in Upper stream station showing (A) U1- Upper Baguik- ikan River, (B) U2- Baguik- ikan River, (C) U3- Lantay River, (D) U4- Muleta-Bongbong River, (E) U5- Muleta Dam.

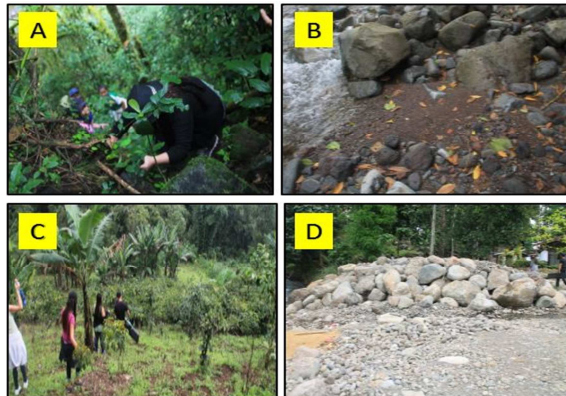
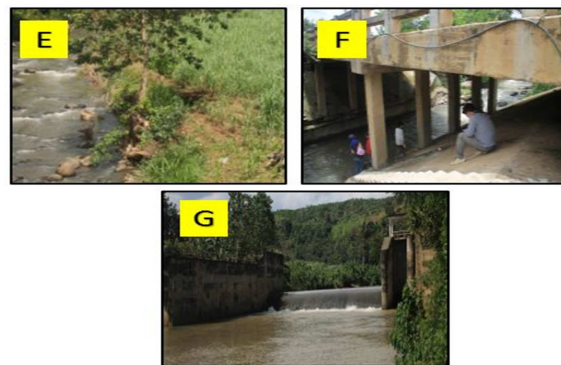
This moderate occurrence of siltation especially in the Muleta Dam may be pointed to the quarrying activities occurring in Muleta-Bongbong River and agricultural cultivation specifically rice fields along the river. This is so because Muleta Dam is the catchment area of all upstream tributaries going downstream. Moderate deposition of gravel and coarse sand bars forming at the middle of the river (Fig. 5B) was caused by the occurring moderate erosions of unstable banks.

**Fig. 5.** Abiotic components showing (A) Steeply sloping landscape and small areas of erosion, (B) Dry Land Farming (banana and coffee plantation), (C) Quarrying activities as landscape stressor, (D) unstable left bank, (E) presence of Bridge, (F) quarry activity and (G) presence of dam and engineered channel.

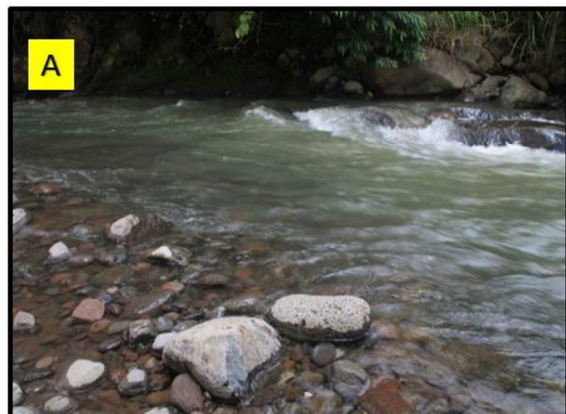
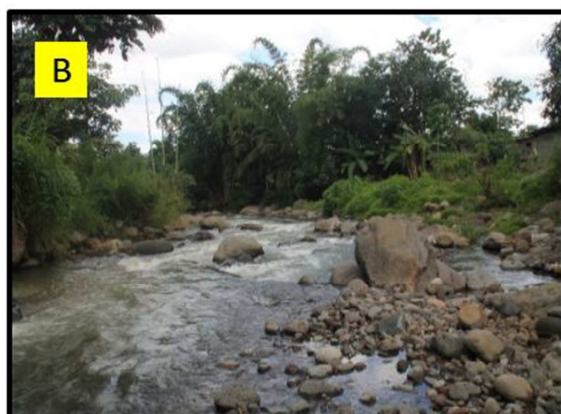
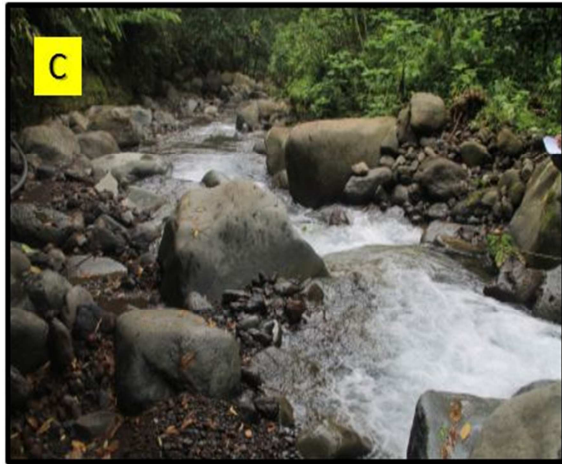
**Fig. 6.** Abiotic parameters showing (A) Bottom substrate of Muleta River in Upper Baguik- ikan, and (B) Channel alteration seen on the increase bar formation at the Muleta- Bongbong River and (C) Upper Baguik- ikan River.

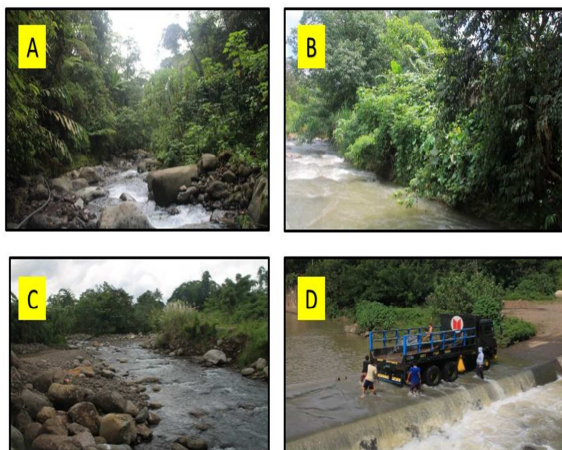
**Fig. 7.** Biotic components showing (A) Canopy Cover, (B) Streamside cover, (C) open canopy, and (D) Anthropogenic activity as a biological stressor.

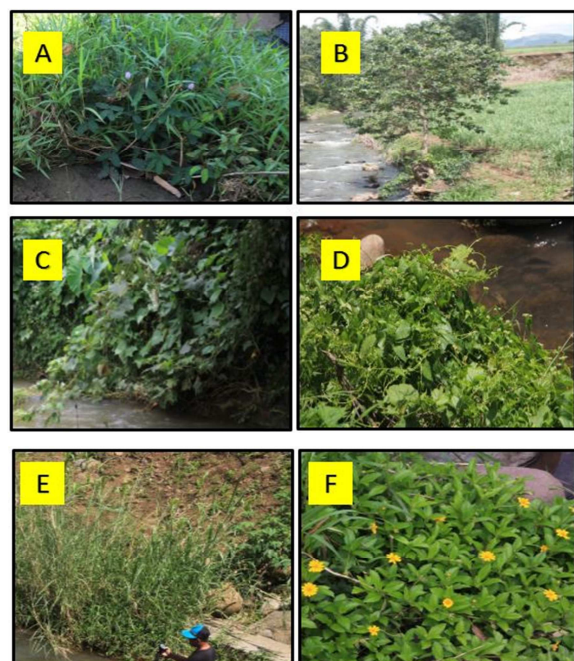
**Fig. 8.** Invasive species present along upper stream of Muleta River (A) *Mimosa invisa*, (B) *Gmelina arborea*, (C) *Dioscorea bulbifera*, (D) *Chromolaena odorata*, (E) *Saccharum spontaneum* and, (F) *Spagneticola trilobo*.

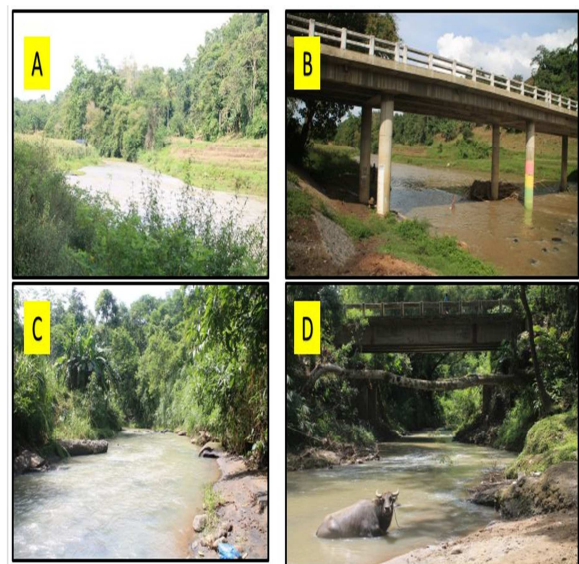
There is an evident of erosion on the right bank. Also, we observed a dead animal inside the cellophane with a very foul smell. Moreover, a bridge is present in this area. Lastly, Masimag River is surrounded with urban residential, sparse shrubs and trees and a very unstable left and right banks (Fig. 9D).

The river has many eroded areas and a more disturbed area compared to other sampling area in midstream part of Muleta River. A bridge is also present in the site.

**Fig. 9.** Assessment Areas in Midstream station showing (A) M1- Muleta River in Malinao Bridge, (B) presence of bridge in M1, (C) M2- Lalapoy River, and (D) M-3 Masimag River.

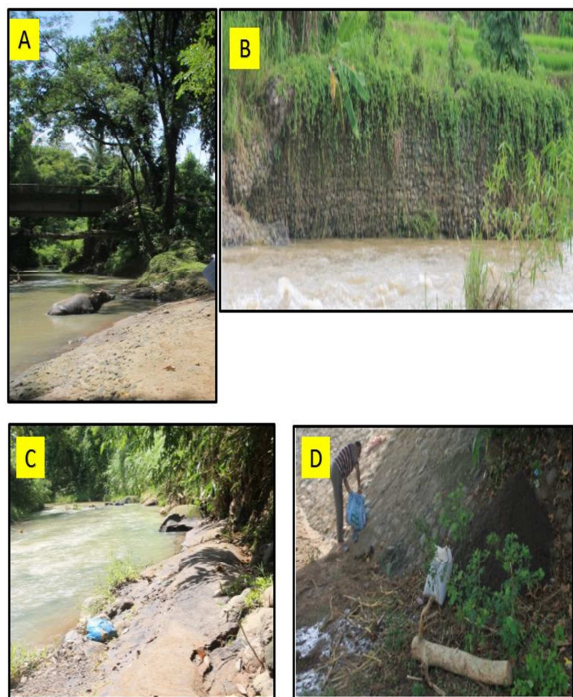
**Fig. 10.** Abiotic components showing (A) hydrologic connectivity (M3), (B) Channel alteration at assessment area (M1), (C) bank erosion (M2), and (D) stock sand at assessment area (M1).

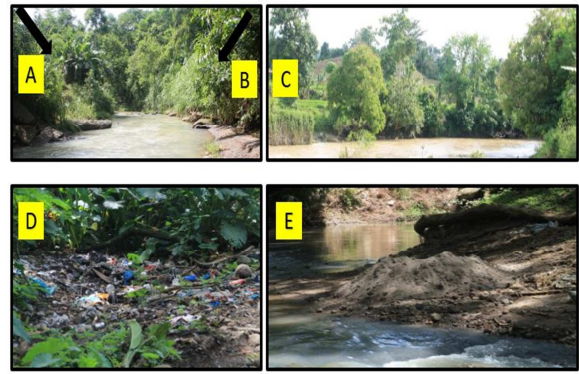
**Fig. 11.** Biotic components showing streamside cover at (A) right side and (B) left side of assessment area 2 (M1) and (C) patch structure, (D) trash and, (E) resource extraction as physical structure stressor.

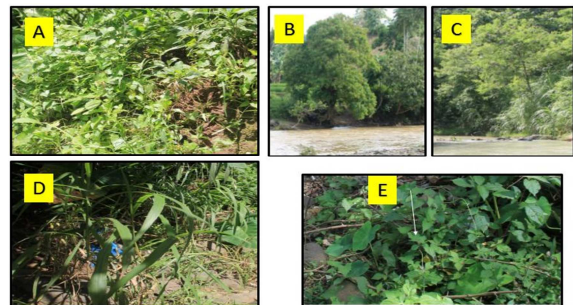
**Fig. 12.** Invasive species present along upper stream of Muleta River (A) *Chromolaena odorata*, (B) *Gmelina arborea*, (C) *Dioscorea bulbifera*, (D) *Leucena leucocephala*, and (E) *Imperata cylindrical*.

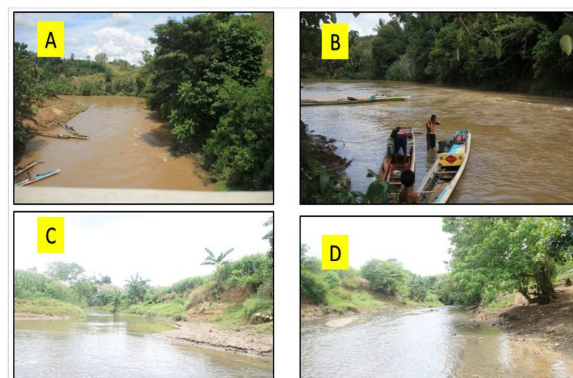
The assessment area 3 or downstream part of Muleta River located at Barangay Omonay, Damulog, Bukidnon has three (3) sampling areas, namely; the Muleta River junction, Lumatong and Omonay. Muleta River junction has a flat to rolling slope (Fig. 13A). It is covered with dense vegetation at the right bank but little to no vegetation at the left bank due to tree/sapling and shrub removal by the settlers nearby. Also, anthropogenic activity of the nearby residents is very evident such as bathing, washing and boating (Fig. 13B). A bridge is present in the site with several residential houses located at the left side of the bank. Lumatong, on the other hand located 1 km from the main highway is surrounded by corn, banana and sugarcane plantation with few trees and shrubs (Fig. 13C). Massive and intense bank erosion observed in the left side of the river. Omonay River is generally flat to rolling slope surrounded with sugarcane, rubber plantation and sparse trees and shrubs at the left and right bank of the river (Fig. 13D). Eroded banks were visible in the area.

**Fig. 13.** Assessment area showing (A) D1- Muleta River junction, (B) anthropogenic activity of the settlers as landscape condition stressor in D1, (C) D2- Lumatong River with intense bank erosion at the left bank, and (D) D3- Omonay River with eroded banks.

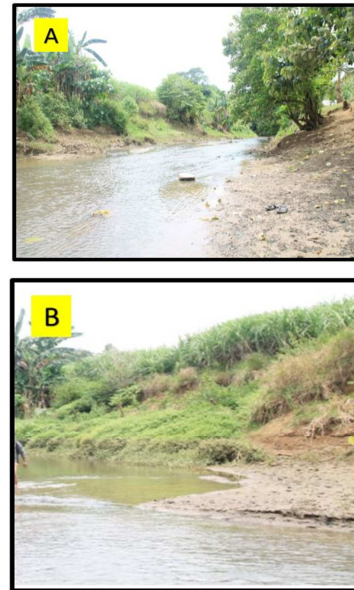
The floodplain which supports riparian vegetation is less frequently inundated (Fig. 14).

The major stressors of landscape, hydrologic and physical structures namely, dry land farming, row crop agriculture, urban residential, excessive sediment and non-point source discharges (urban run-off and farm drainage). According to Dosskey *et al.* (2010), tree stems, root wads, and large branches collectively known as plant debris lodge in channels and provide roughness to the channel bed and bank toe slopes that slows stream velocity and promotes stability and deposition. The river instream cover is made up of 10-30% mix of gravel and rocks and is surrounded with 50-75% of fine sediments. Banks are moderately unstable with moderate frequency and size of erosional areas. The occurring siltation in the site may be attributed to the occurring bank erosions triggered by the agricultural intensification and the removal of trees/ sapling and shrubs along the rivers which had also reduced the coverage of natural vegetation.

**Fig. 14.** Abiotic components of Muleta River (downstream) showing (A) Hydrologic connectivity, and (B) Bank erosion/ excessive siltation.

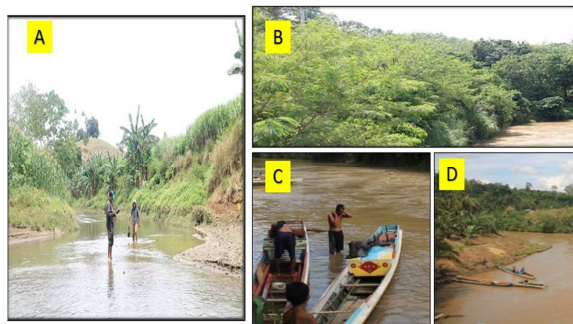
**Fig. 15.** Biotic components showing (A) Canopy Cover, (B) Streamside cover, (C) open canopy, and (D) Anthropogenic activity as a biological stressor.

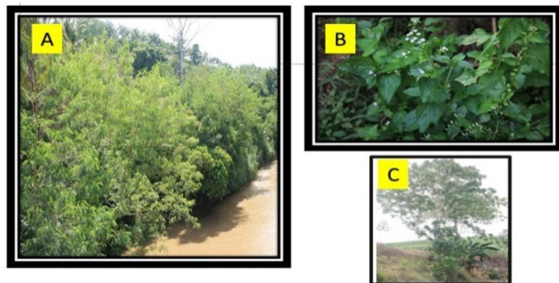
Dominating invasive plant species were *Chromolaena odorata*, *Leucena leucocephala* and *Gmelina arborea* (Fig. 16). Biological stressors observed in the sites are the excessive human vegetation, tree/ sapling or shrub removal, lack of vegetation management to conserve natural resources and presence of exotic plant species. Vegetation along the river in low degree of patch diversity and complexity with only two or three patch types mainly composed of low-structured forest with present patches of shrub-land/ herbaceous vegetation.

**Fig. 16.** Invasive species present along the midstream stations of Muleta River showing (A) *Chromolaena odorata*, (B) *Leucena leucocephala* and, (C) *Gmelina arborea*.
