Identification of management & conservation issues in built heritage (a case study of Zar Dheri Buddhist complex District Mansehra, Khyber Pakhtunkhwa, Pakistan)

Key words: Zar Dheri, Built Heritage, Conservation, Management issues.

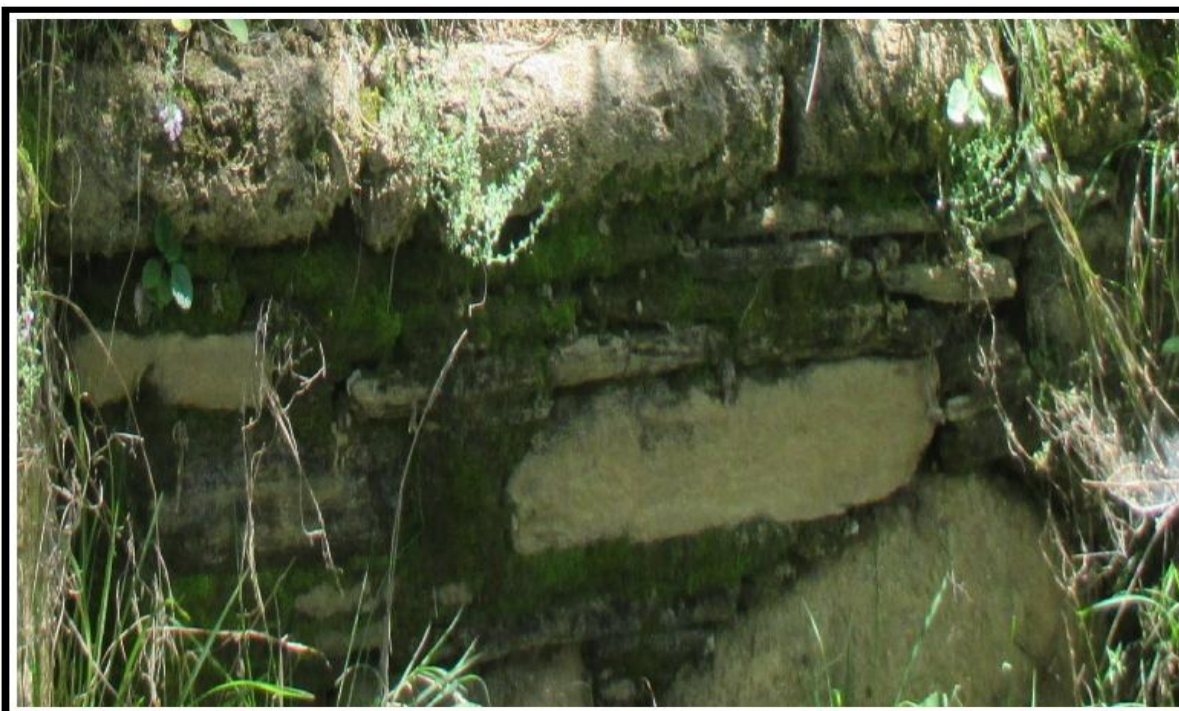
Fig. 3. Damage Caused Mosses.

Each historical building and cultural value is an expression of accumulation and a bridge from past to present (Colette, 2007). The climatic change is one of the factors of constant damage to Zar Dheri site (Fig. 3). The climate is warm and temperate in Mansehra. The rainfall in Mansehra is significant, with precipitation even during the driest month. The average annual temperature in Mansehra is 18.5 °C. In a year, the average rainfall is 1445 mm. Monsoon season is from middle and late June to October. The rains provide a welcome relief from the scorching summer heat and the whole state is covered with greens and waterfalls are at their best. Winters are pleasant with low temperatures and less humidity (Gul *et al.*, 2016).

Their leaves are usually photosynthetic, green having chlorophyll, smaller and greenish in color. The mosses are present in covered & uncovered area, need the clearness operation at Zar Dheri to remove the mosses and other types of biological growth (Farooq

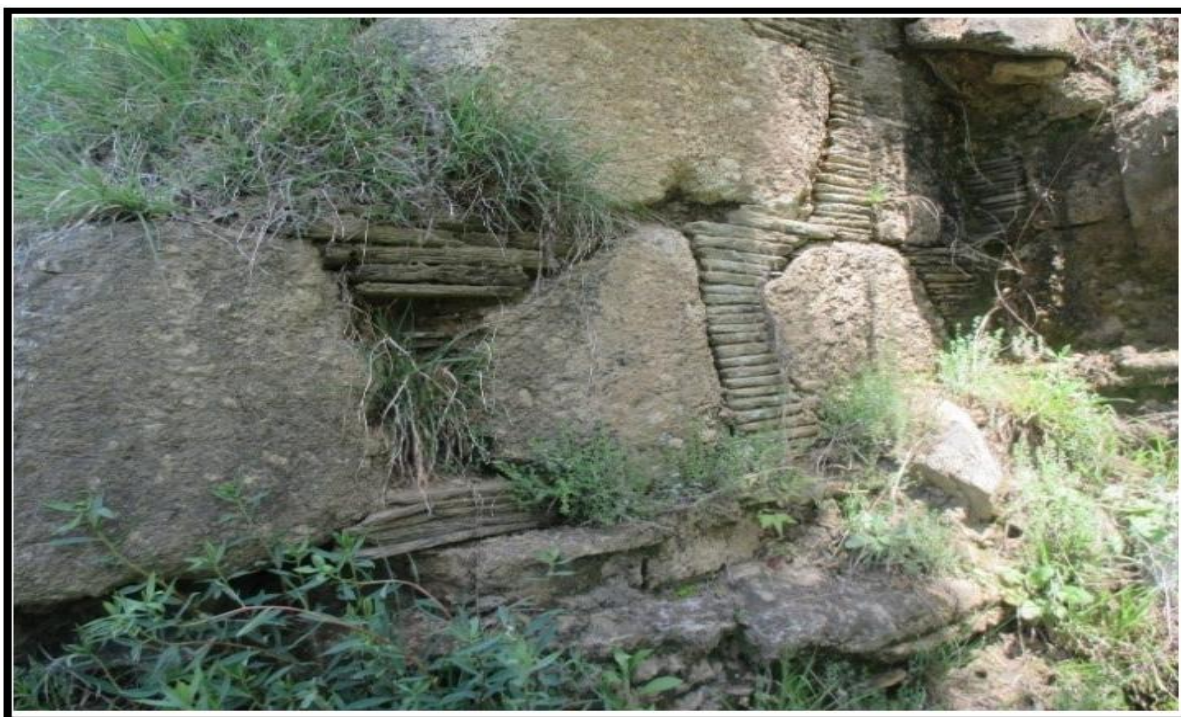
Fig. 5. Closer View of Biological Growth at Zar Dheri on Main Stupa.

The exposed structural remains need to be properly conserved by the professionals to stop further damage to the site. The biological growth at the site may be stop by removing the herbs and shrubs on regular basis.

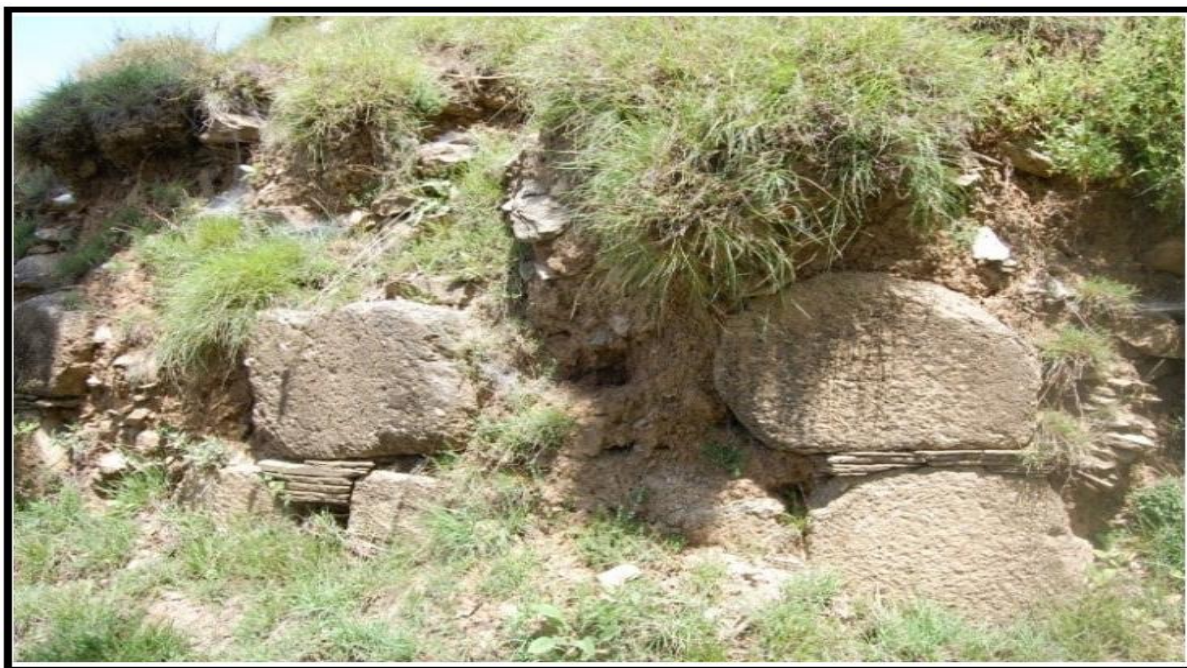
Fig. 7. Biological Growth on the Southwestern side of the Main Stupa at Zar Dheri.

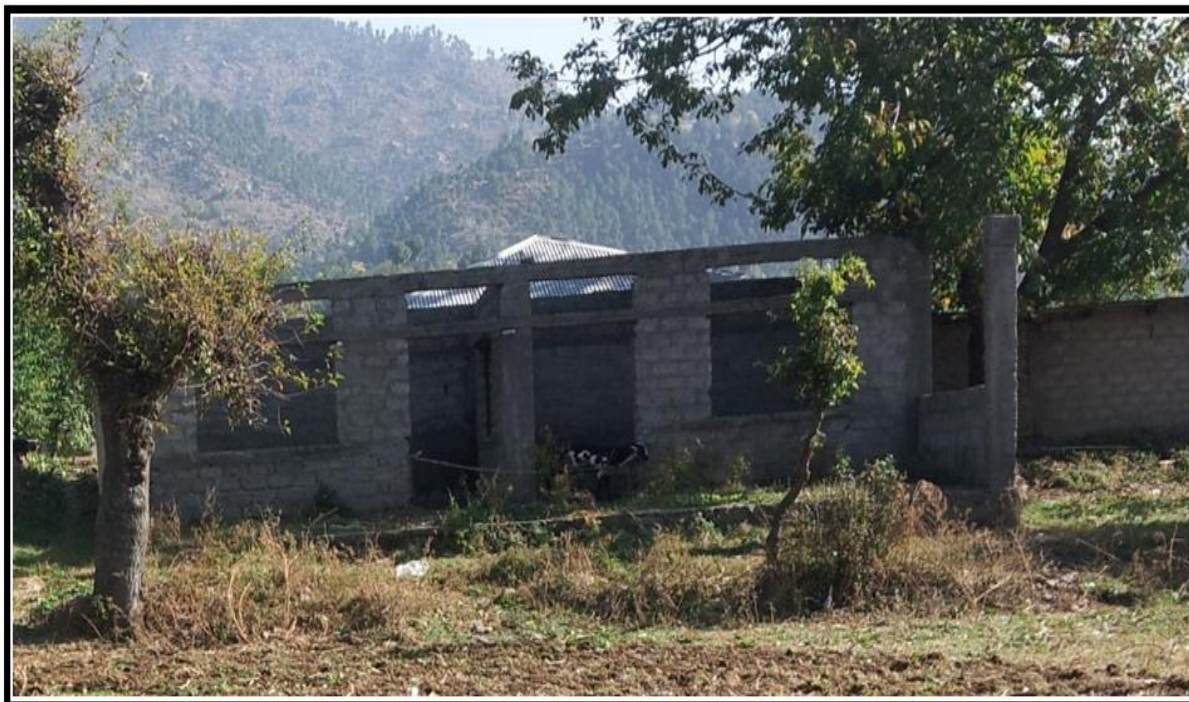
Fig. 8. Under construction House built in the Monastery area.

With the increase in population at an alarming rate, new buildings (Fig. 8) are being constructed on and around Zar Dheri. The newly constructed buildings on one hand, are constantly covering the ancient remains, on the other hand, the dressed blocks of the stupa and monastic establishment are being pulled out and reused by the local community. With the result the entire site is losing its original shape and disappearing.

After the detailed documentation and demarcation the encroachment and alteration made by the local community need to be removed on urgent bases. This possible only if all the stakeholders (i.e. the DOAM, Government of Khyber Pakhtunkhwa, the local community and the Ministry of Culture and Tourism) are taken on board. The owners of the site may be compensated and rehabilitated.

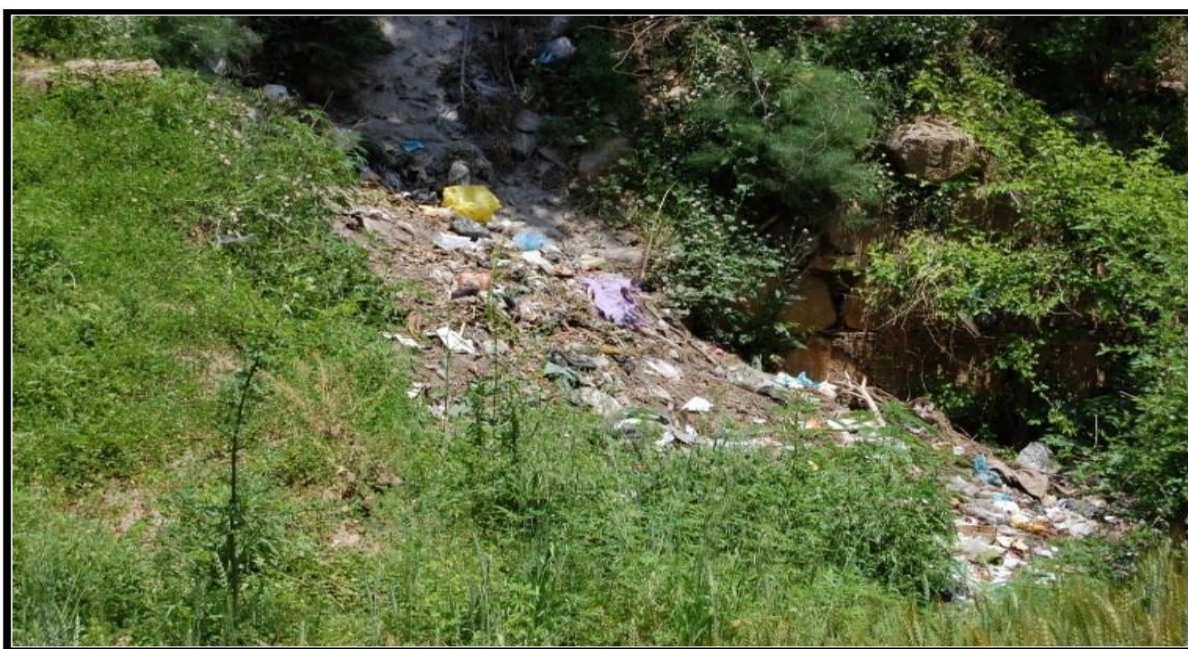
Fig. 9. Garbage thrown by the Local Community.

Fire is the rapid oxidation of a material in the chemical process of the combustion, releasing heat, light and various reaction products slower oxidative processes. At the Zar Dheri site, the waste material of the crops are being burnt along the structural walls. This has caused breakdown of the stone structures and the colour of the stone changes due to black soot. Domestic wastes material also is another issues, the local people of the local community throw their garbage (Fig. 9) on the site, which is causing biological growth at the site.
